BISHOP HOME INSPECTIONS, LLC.

Inspection address: 123 North Street

Date of Inspection: 8-3-05

#2005-0001

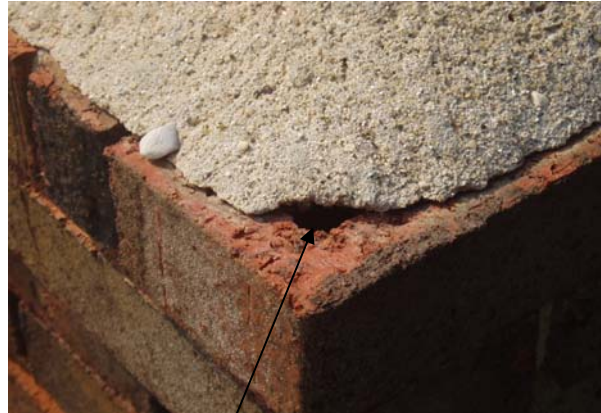
Chimney cap hole needs proper sealing.

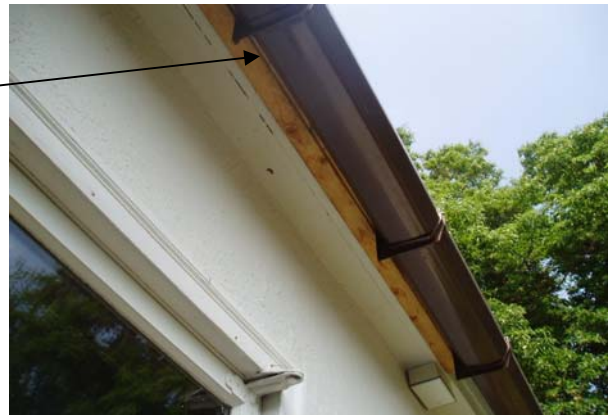
Gutter brace needs painting.

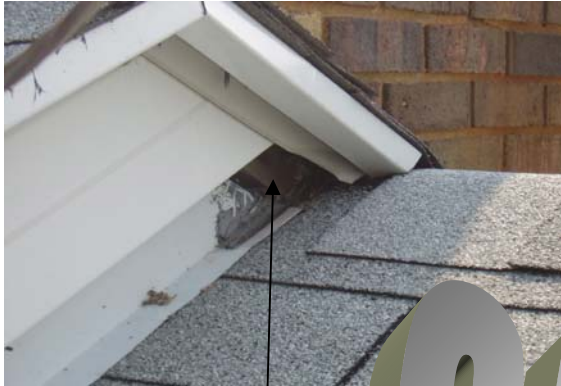
Missing piece of siding

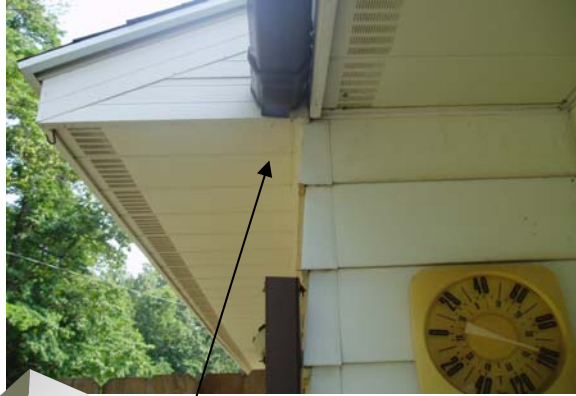
Gutter downspout

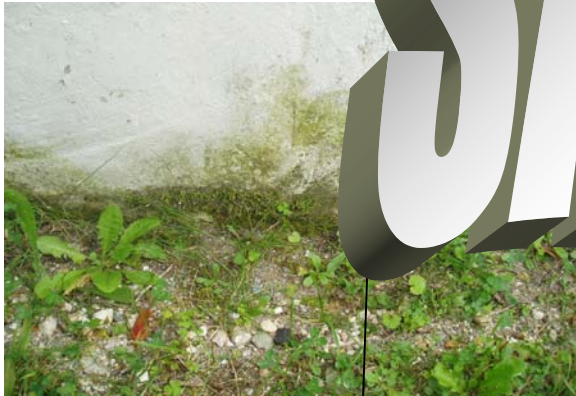
- 1) There is Mold/Mildew at base of front side of house. Keep this clean of mold and mildew.
- 2) Keep stucco siding cracks sealed with proper sealant.
- 3) The kickplate area located at the side entrance door should be attached and sealed to prevent wet rot behind that area.
- 4) Kitchen window exterior upper trim piece is cracked and wet rot. Recommend replacing.

Mold and Mildew on stucco

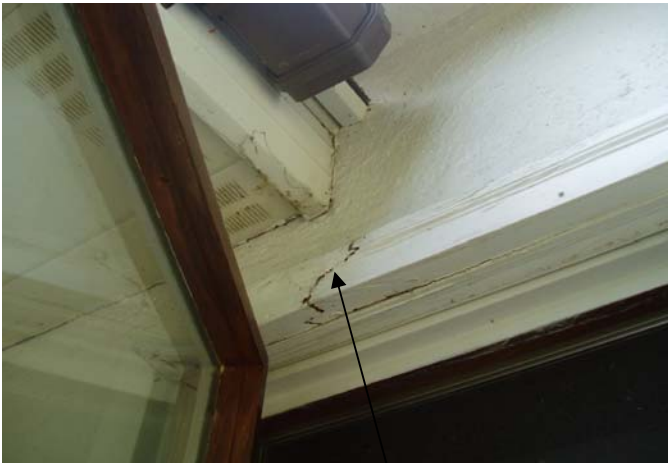
Wet rot above kitchen window

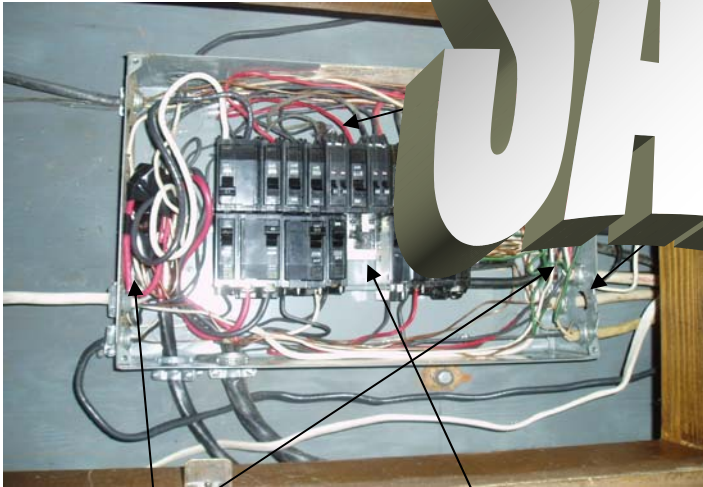
- 1) Missing knockout and knockout cover
- 2) There is sheathing on a romex wire
- 3) Unused breakers should be broken
- 4) Loose unused(?) wires should be

Loose wires

Unused breakers

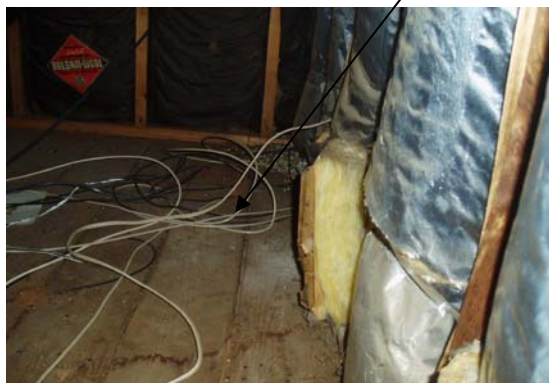
Loose wires in upstairs bedroom attic area.

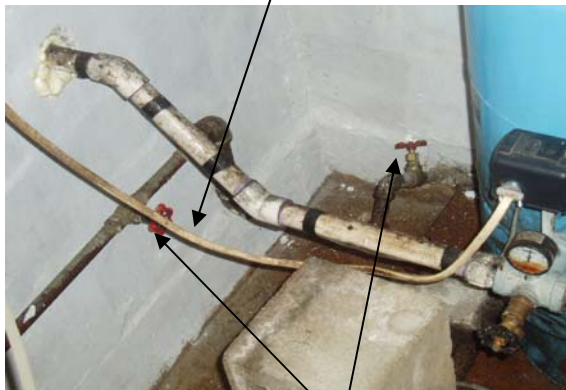
Loose wire in water softener room

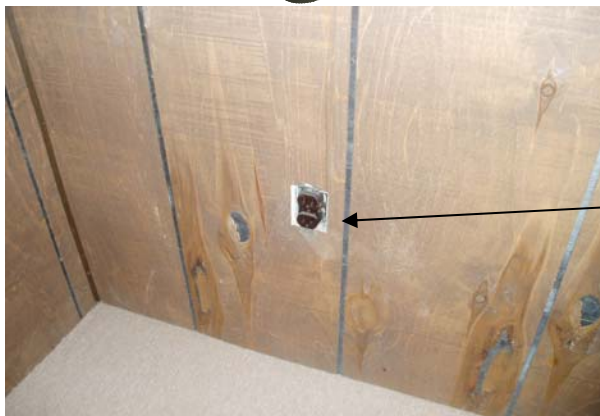
- 1) At bottom of stairs the first light switch
- 2) One outlet cover missing.

No outlet cover

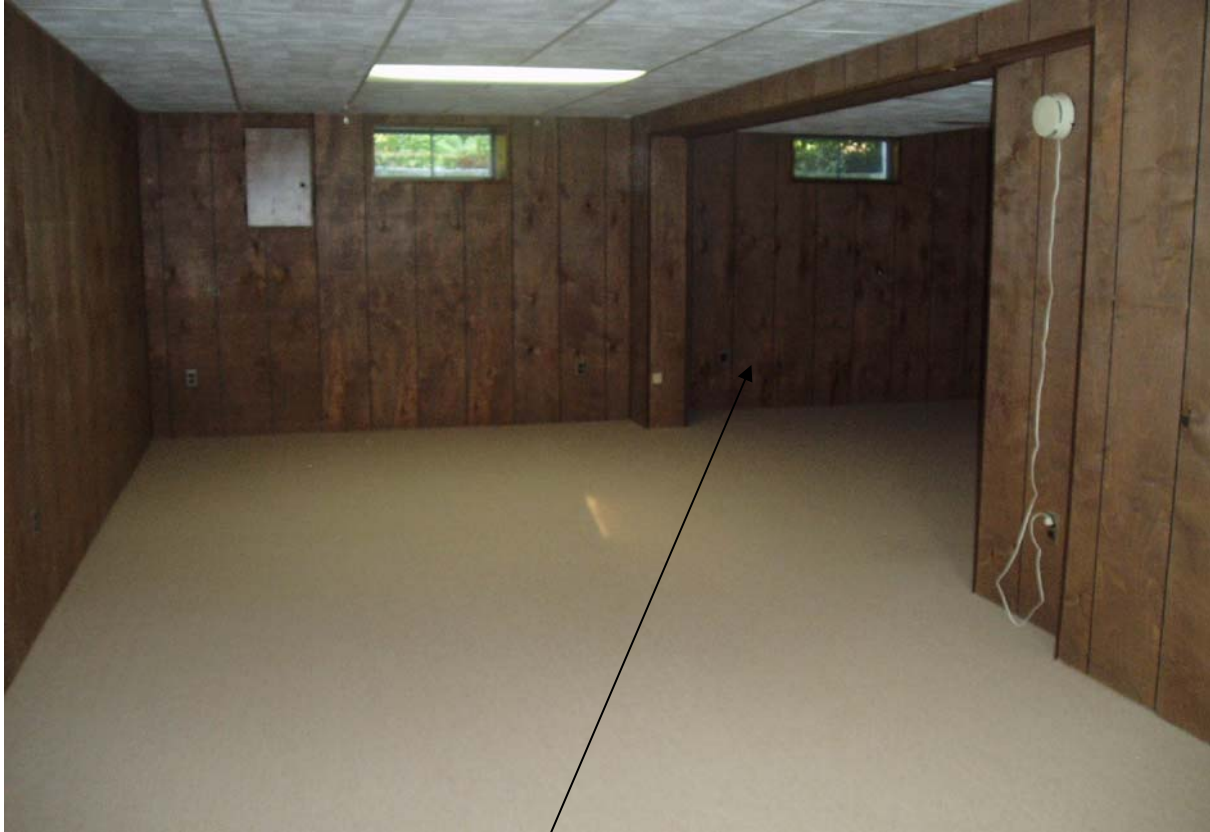
Outlet missing

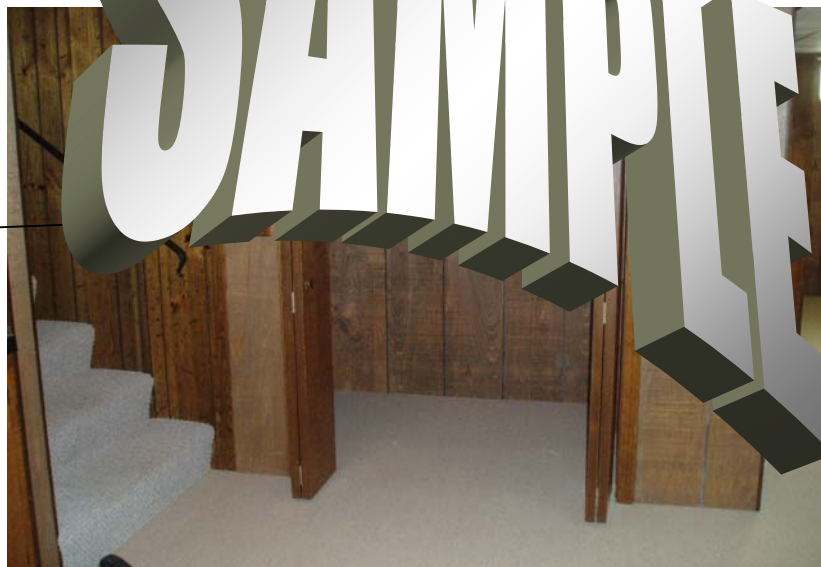
Switch on left
does not function
anything.

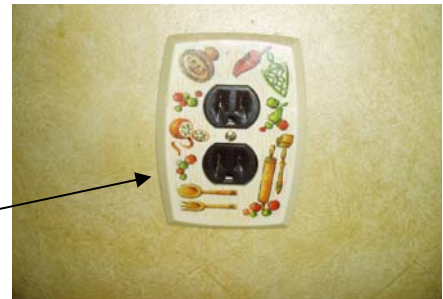
Tester shows open ground
